A walkover survey of the Barbrook Mill site

Introduction

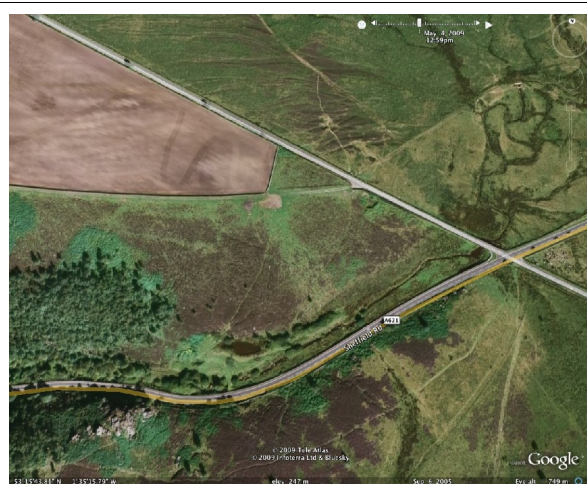
Aerial photo – the Barbrook Mill site
(Google Earth 2009)

The Google Earth (2009) picture shows the various tracks (Ref 6/15) particularly well, and some of the other features more faintly.

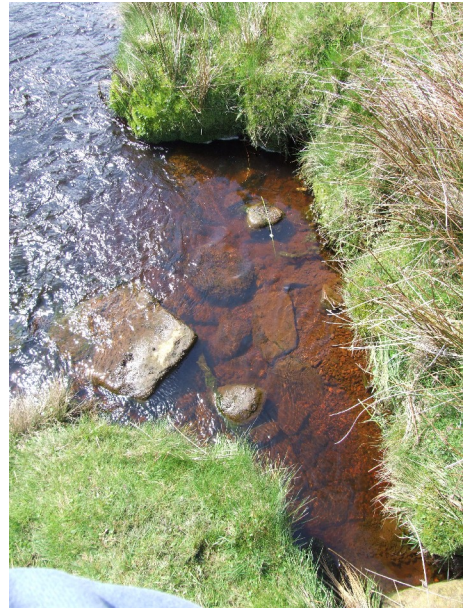
Photo 2 - L shaped feature (10/12)

Ref	Description	Photo
7	A small pool of water, approx. 2.5m in diameter, with no obvious outflow. No real evidence of human activity, assumed to be a natural feature.	
8	Between the pool and the wall are two small depressions, one 2m diameter x 50cm deep, the other 5m x 2m x 1m deep. These look like small quarries, but are much more weathered than 5, and hence are probably much older. Faint tracks connect them, but these may be cattle paths.	
9	Flat grassy area beside the wall, here over 2m high, with a marshy area between it and the pool by the bridge. Some evidence that the area was built up and levelled, perhaps as a base for ephemeral buildings such as sheds. The bridge itself is arched, of gritstone block construction. As such, it is 19thC or earlier, as more recent road bridges are usually concrete.	
10/12	The pool by the bridge is created by a dam of rocks across the Brook (marked as a pink dumb-bell on the OS map). While these could be natural, a number of indicators suggest not. On the north bank, an 'L' shaped feature looks like a blocked-off outflow (mill leat). On both banks, by the rock dam, there are square hollows opposite each other that could have supported timbers to create a higher dam. The marshy area mentioned at 9 could be the remnant of the larger pool a higher dam would have created. Just downstream of the dam, there was evidence of a narrow (15cm wide) channel, approx 50cm deep, almost obscured by vegetation.	2

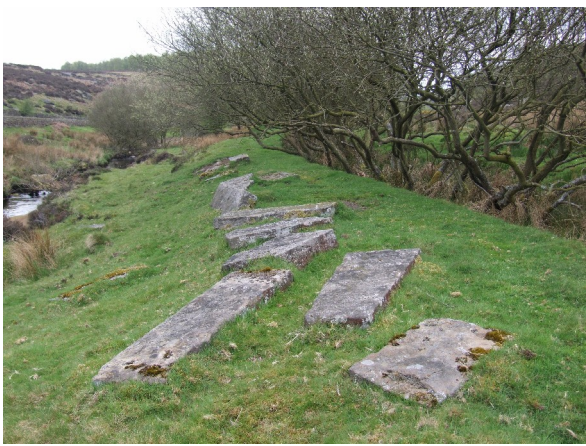
Photo 3- Quarried slabs (23)

Ref	Description	Photo
20/21	The former mill race is bounded on the SE by a straight wall, and on the NW by a wall which curves in the middle. The SE wall, above the Bar Brook, is more substantial, and is 1m wide at the top, rising to almost 2.5m above the surface of the Bar Brook where it adjoins the pond.	
22	The upstream end of the mill race has been filled in and walled across. At this point, the race has no open water, just bog.	
23	A number of quarried gritstone slabs have been placed beside the mill race, on the SE facing bank. These could once have formed part of a larger weir across the brook (see 24), or possibly came from the filled-in section of mill-race.	3
24	Weir (marked on OS map). Dressed stone slabs, now only 30-40cm high. Just above it can be seen the cut-off channel that once connected to the mill-race (20/21)	
25	Mill pond, approx 50m x 20m, depth unknown. The south side of the pond is an embankment, as marked on the OS map. The north-east side is reinforced by a continuation of wall mentioned at 19. The water surface is approx. 3.5m above the water level of the brook at the old bridge (27).

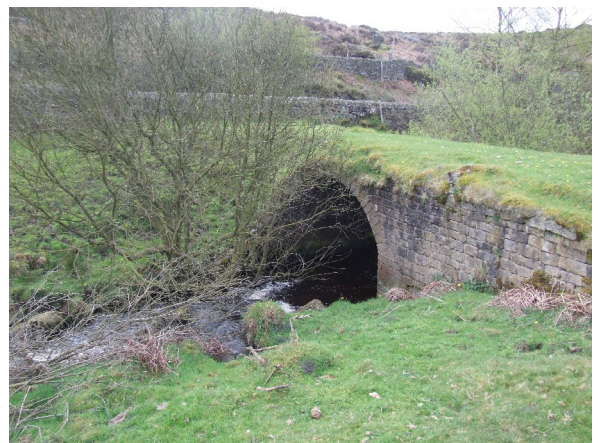
Photo 4 - Old bridge (27)

26	Small masonry structure, with a channel running under the SE wall of the mill-race. Evidently an overflow to prevent water overtopping the wall. The surface of the mill-race is shown by this to have been about 2m above the Bar Brook at this point.	
27	Old arched bridge and former access to mill site from A621. Of gritstone construction, the arch is 2.2m high, and the roadway on top is 2.5 - 3m wide. The style and condition of the masonry indicates 18th-19th C construction. The roadway curves to the left (NW) of the pond (25) and passes between the depression (31) and the building (32), leading to a track (33).	4
28	The land to the west of the bridge and track (27), on the north bank of the brook has been terraced. The lower terrace is ~1m above the brook, and the upper terrace is ~1.5m above that. Both terraces extend westwards ~50m, almost to the trees. There are a number of hollows and bumps on the terracing, probably indicating building foundations. About half way along the upper terrace, there is a gap or depression in the bank, possibly the site of a connecting stairway.	9

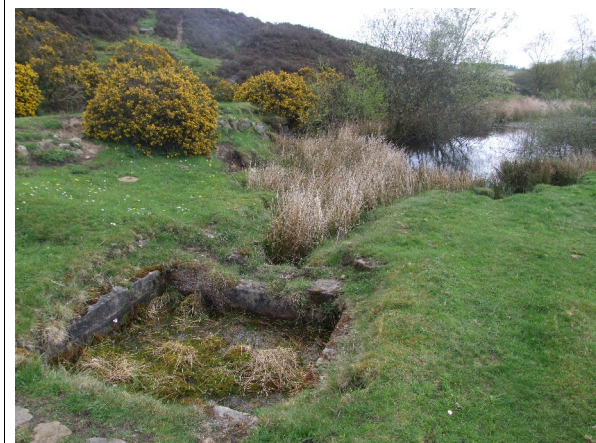
Photo 5 - Small square tank (30)

29	A small dip in the southern bank of the pond, with a boggy area below it leading down to the brook. Apparently the location of the pond overflow, probably where a sluice gate would have controlled the level of the pond.	
30	The main outflow from the pond leads to a small, square (1.8m x 1.8m) gritstone chamber, marked on the OS map. Possibly the location of a sluice to control the flow to the mill wheel. The water then flowed beneath the roadway (27) to the large depression (31).	5

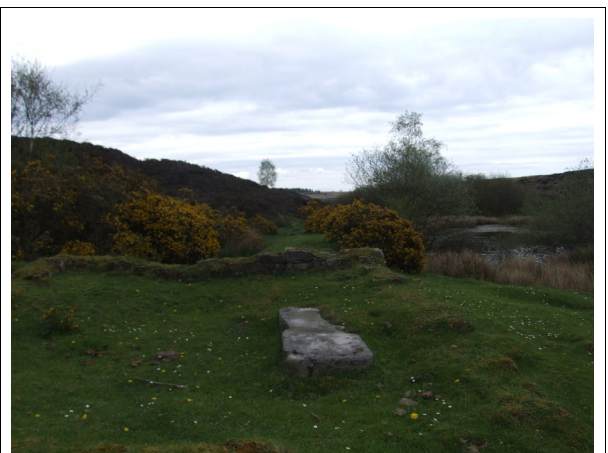
Photo 6 - Foundation walls and machine slab (32)

Ref	Description	Photo
31	Large depression, ~10m diameter, cutting across the upper terrace (28). It is 4m deeper than the roadway, and ~1.5m deeper than the lower terrace, so the bottom is at or just above the level of the brook. This is most likely the location of the millhouse and mill wheel, which Gifford (1999) states was an undershot type, in 1869. The water exit channel is not visible at this point, but would have run from the downstream side of this depression, beneath the lower terrace to the brook, some 50m downstream (see also 35)	12
32	Clear set of gritstone building foundations, see sketch plan. The walls are 40-50 cm wide, and stand 10-30 cm high. The sketch also shows the road/trackway, the square tank (30), the deep depression (32), the pond overflow (29) and part of the terracing (28). The slab has two bolts set in it, indicating it was a machine base.	6
33	Track leading from mill site, diagonally up the hillside and running through the trees to Bar Lane. Built up in places, the lower part is clearly an extension of the mill roadway (27), but the upper part through the trees is probably just a cattle path.

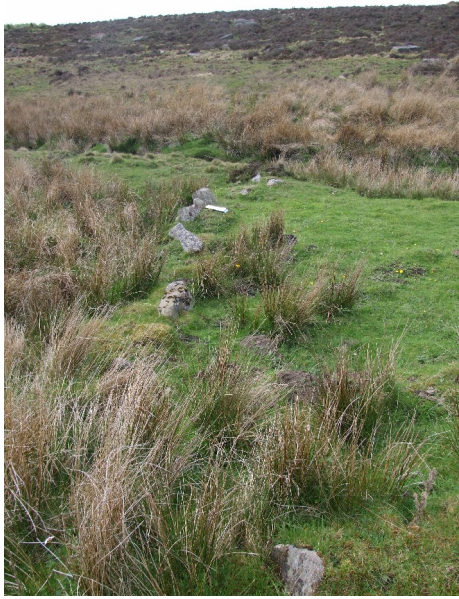
Photo 7 - Alignment of stones (37)

37	On the south side of the brook, an alignment of ~10 gritstone blocks, each 30-50 cm long, ~20cm wide, projecting 20-40 cm above the land surface. The whole assembly is 9-10m long, almost straight, but curving slightly at the eastern end, where it adjoins a large natural boulder.	7
38	A small semicircle of stones edging a raised (~1m above brook), flat platform, adjacent to the pool (10/12), and about 3m from the brook. The platform is about 5m x 6m in extent,, enough for a small building or a shed. No signs of foundations.	8

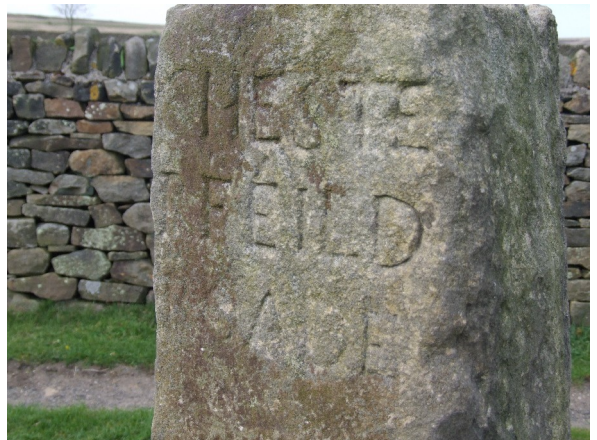
Photo 10 - Guide Stoop (39)

Ref	Description	Photo
39	The 'Stone' marked on the OS map is of gritstone, 1.7m high, 25cm x 30 cm in section, with an inscription on one side stating "CHESTE / RFEILD / 10ADE". In shape and inscription, it resembles the Guide Stoops described by Smith (2009), and is thus probably early 18thC. The "10ADE" part is very worn, and may have said "1710AD", or may be the mason's initials. At that time, Bar Lane was the main road from Baslow to Chesterfield. Barnatt & Smith (2004) show it as a hollow way, and refer to this guide stoop in Figure 56 (page 105)	10

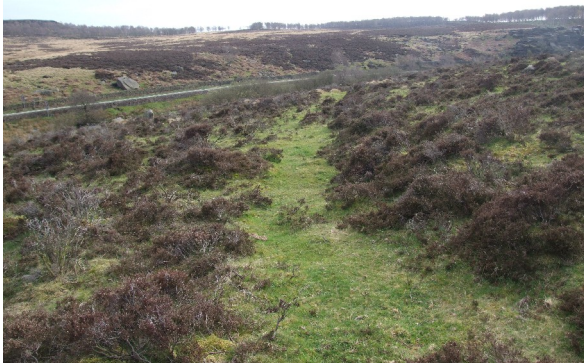
Photo 11 - Track/Hollow way (6)

3	Most of the vegetation in this area is rough grass, sedge and heather, with lots of hummocks like those at Ref 2.	
4	A low straight bank, 20-30cm high, crosses the northern end of the triangle of land to the north of Bar Lane, and the area north of the bank resembles more the field to the west of this triangle of land, which is improved grassland with no hummocks. It may be that this bank was a former field boundary, before walls were realigned to accommodate mechanised farming.	
5	Large oval depression, approx. 10m x 18m x 2m deep. Evidence of a small spoil heap on the SE side. Exposed gritstone outcrops within the depression indicates this was a quarry, possibly the source of material for the walls 1b. The lightly weathered appearance implies this is not very old (<100 years). The land falls away more steeply on the eastern side, down to the Bar Brook.	1
6/15	A clear track runs for about 300m, firstly S from the gate, then veering SW, diagonally across the slope towards the mill pond. Approx. 2m wide, with evidence of ruts about 1.5m apart, in places within banks as if built to provide a consistent moderate slope for carts. A similar but fainter track branches from it, and runs SE to the quarry spoil heap. Barnett & Smith (2004) show these as hollow ways, running parallel to, but south of the 1759 Turnpike, which is now Curbar Lane (Fig 56, page 105)	11

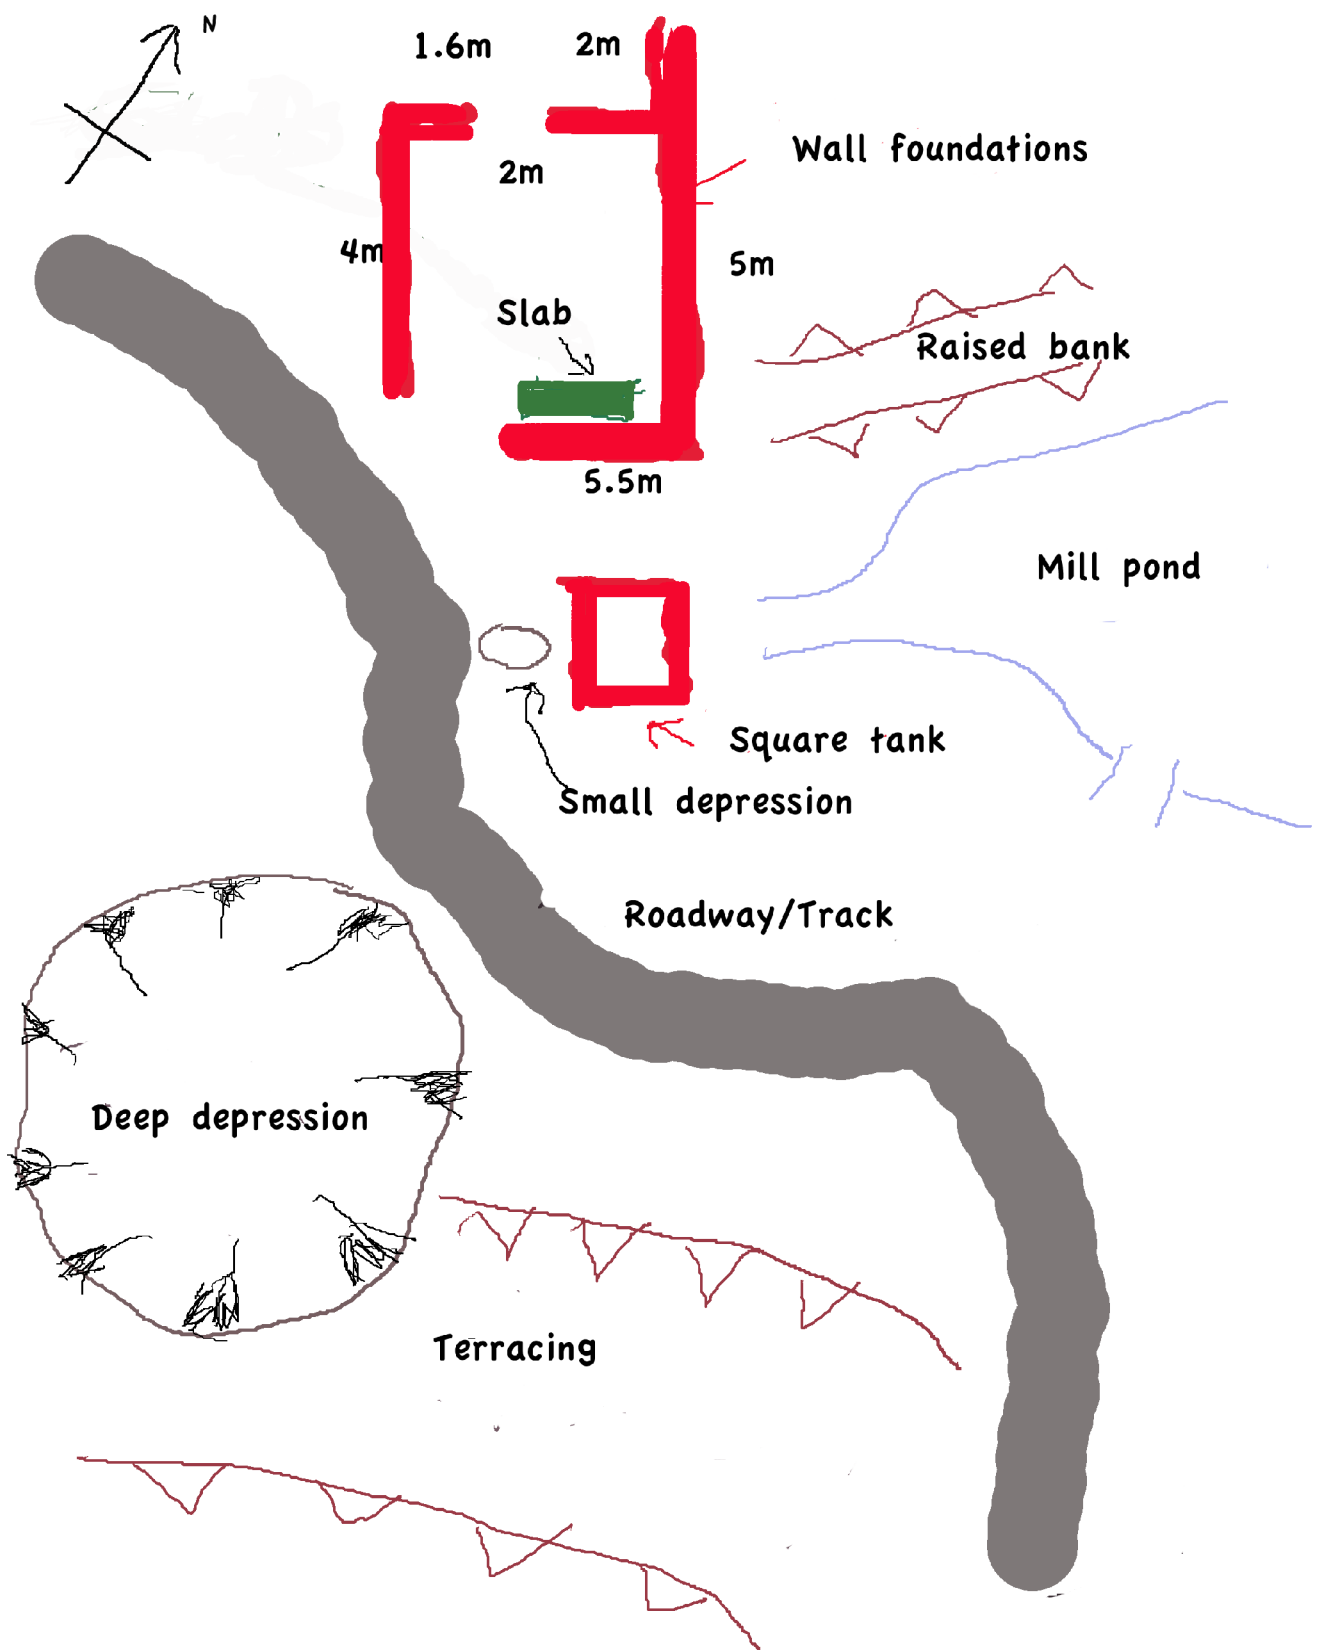
Ref32 - Sketch of building foundations etc (not to scale)
